Manhole Inspection Summary

Manhole # S31MM1019MH

Location Address: **WHITFIELD RD**

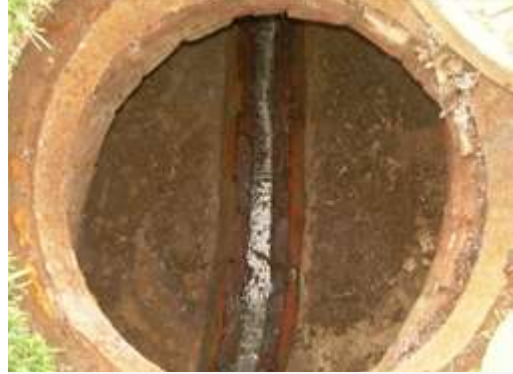
Top View

Surcharge ☒ **Evidence Of Surcharge** Depth: **1** (ft.) ☐ Active Surcharge Present

Evidence of surcharge - Bench debris.

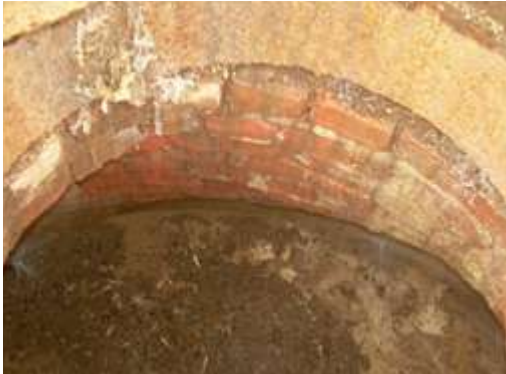
Defect

☒ **Leaks**

Condition: ☐ Sound ☐ Cracked ☐ Root Intrusion ☐ Loose Brick ☒ **Deteriorated**

Infiltration: ☐ None ☒ **Joint** ☐ Cracks ☐ Mortar ☐ Roots ☒ **Wall**

Frame leaks. Adjustment deterioration and infiltration.

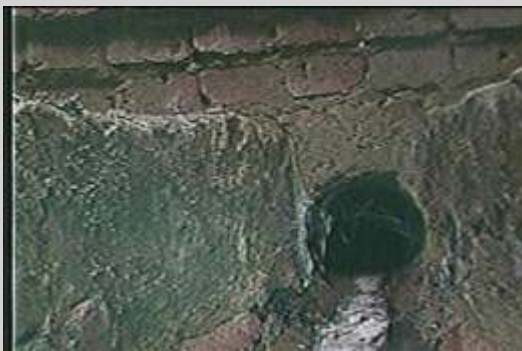
6 in. Circular Gravity Sewer Pipe In @ 6 O'Clock

Condition: ☐ Sound ☐ Cracked ☐ Root Intrusion ☐ Loose Brick ☒ **Deteriorated**

Infiltration: ☐ None ☐ Joint ☐ Cracks ☒ **Mortar** ☐ Roots ☐ Wall

Barrel deterioration and infiltration.
